ALPENA COUNTY LAND BANK AUTHORITY

REQUEST FOR PROPOSAL: ACM/HAZARDOUS MATERIAL ABATEMENT SERVICES

BLIGHT ELIMINATION PROGRAM ROUND 3

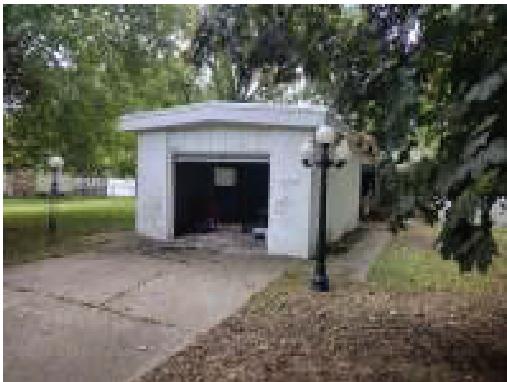
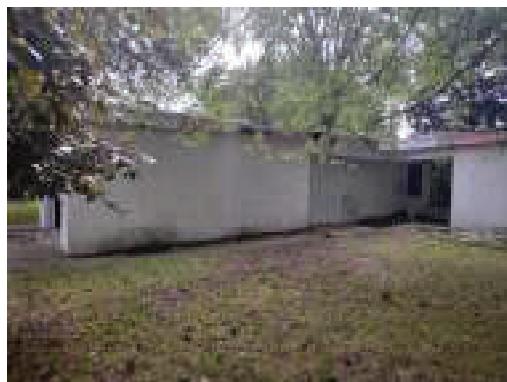
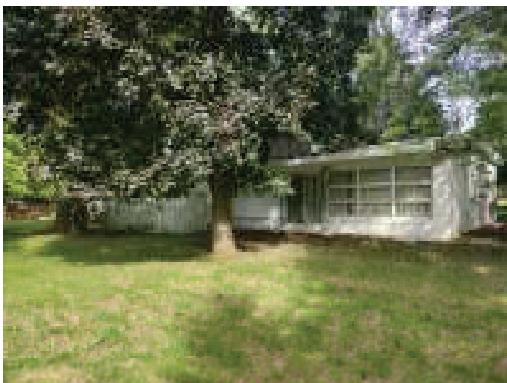
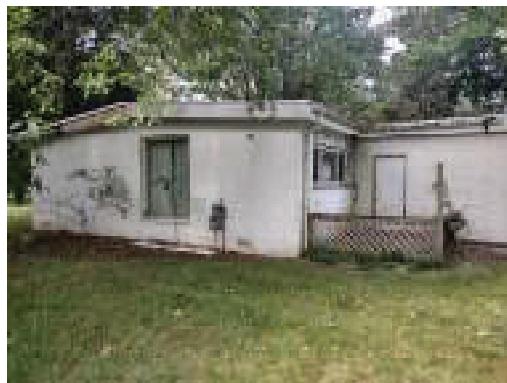
Photograph of the residence/ garage, which has an asbestos containing hot tar roof present.

Prior to the commencement of the any renovation or demolition activities that could impact the ACBMs, Otwell Mawby recommends the ACBMs be removed by a qualified and licensed asbestos abatement professional following all applicable local, state, and federal laws prior to its disturbance. The materials could also be managed during demolition as they are non-friable, although, management during demolition would render the entire debris pile asbestos containing, which would be more costly than removal prior to demolition.

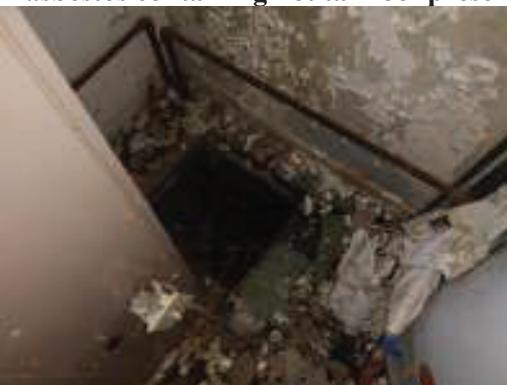
Photograph of the interior of the utility room. The asbestos containing tile is depicted.

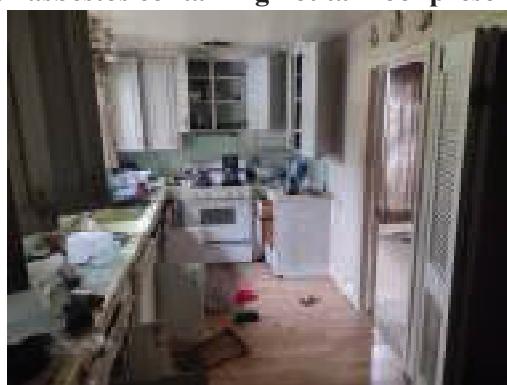
Photograph of the interior of the kitchen. Asbestos containing linoleum is present.

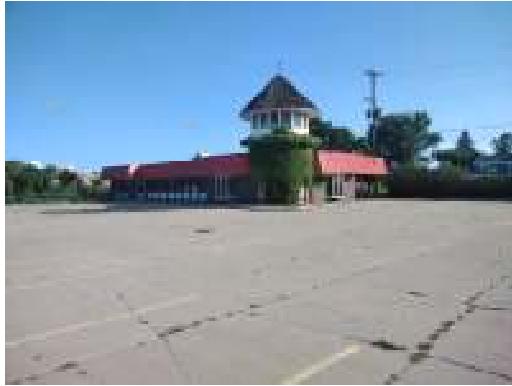
Photograph of the exterior of the building.
The windows have asbestos containing caulk.

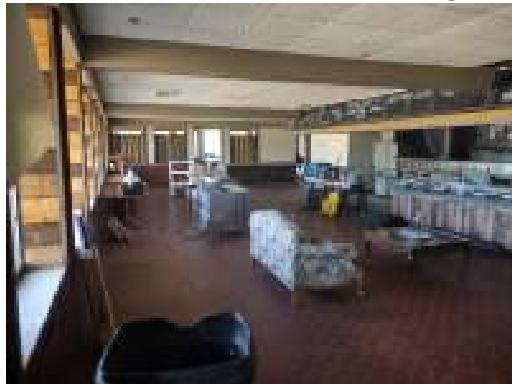
Photograph of the interior of the building.
The windows have asbestos containing caulk.

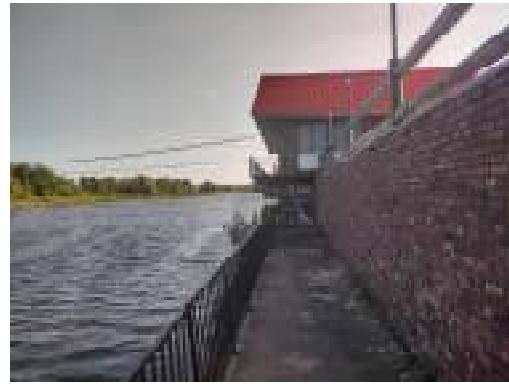
Photograph of the area where the building abuts the river.
The windows have asbestos containing caulk.

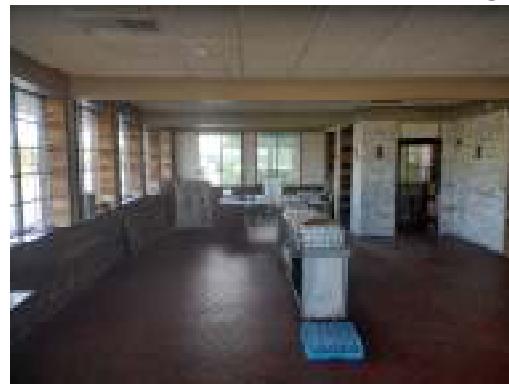
Photograph of the interior of the building.
The windows have asbestos containing caulk.

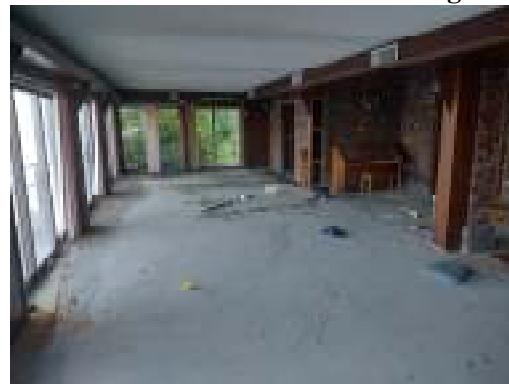
Photograph of the interior of the building.
The windows have asbestos containing caulk.

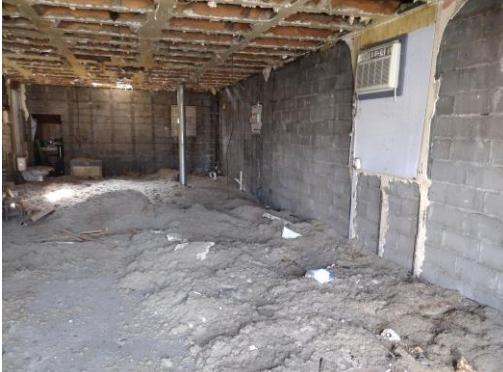
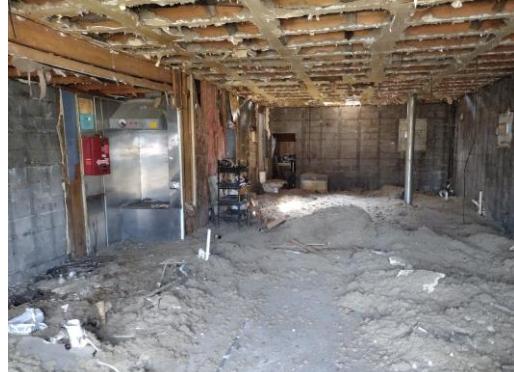
Photograph of the interior of the building where the floor tile/ mastic is present.

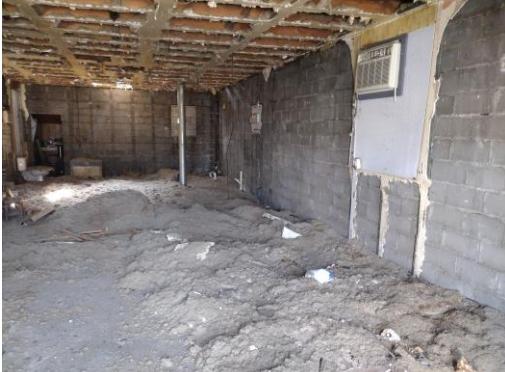
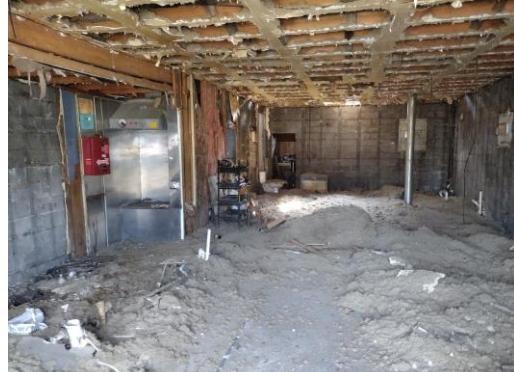
Photograph of the interior of the building where the floor tile/ mastic is present.
